**THÈSE**

**Influence of casting defects on the  
fatigue behaviour of an A357-T6  
aerospace alloy**

**l'Institut National des Sciences Appliquées de Lyon**

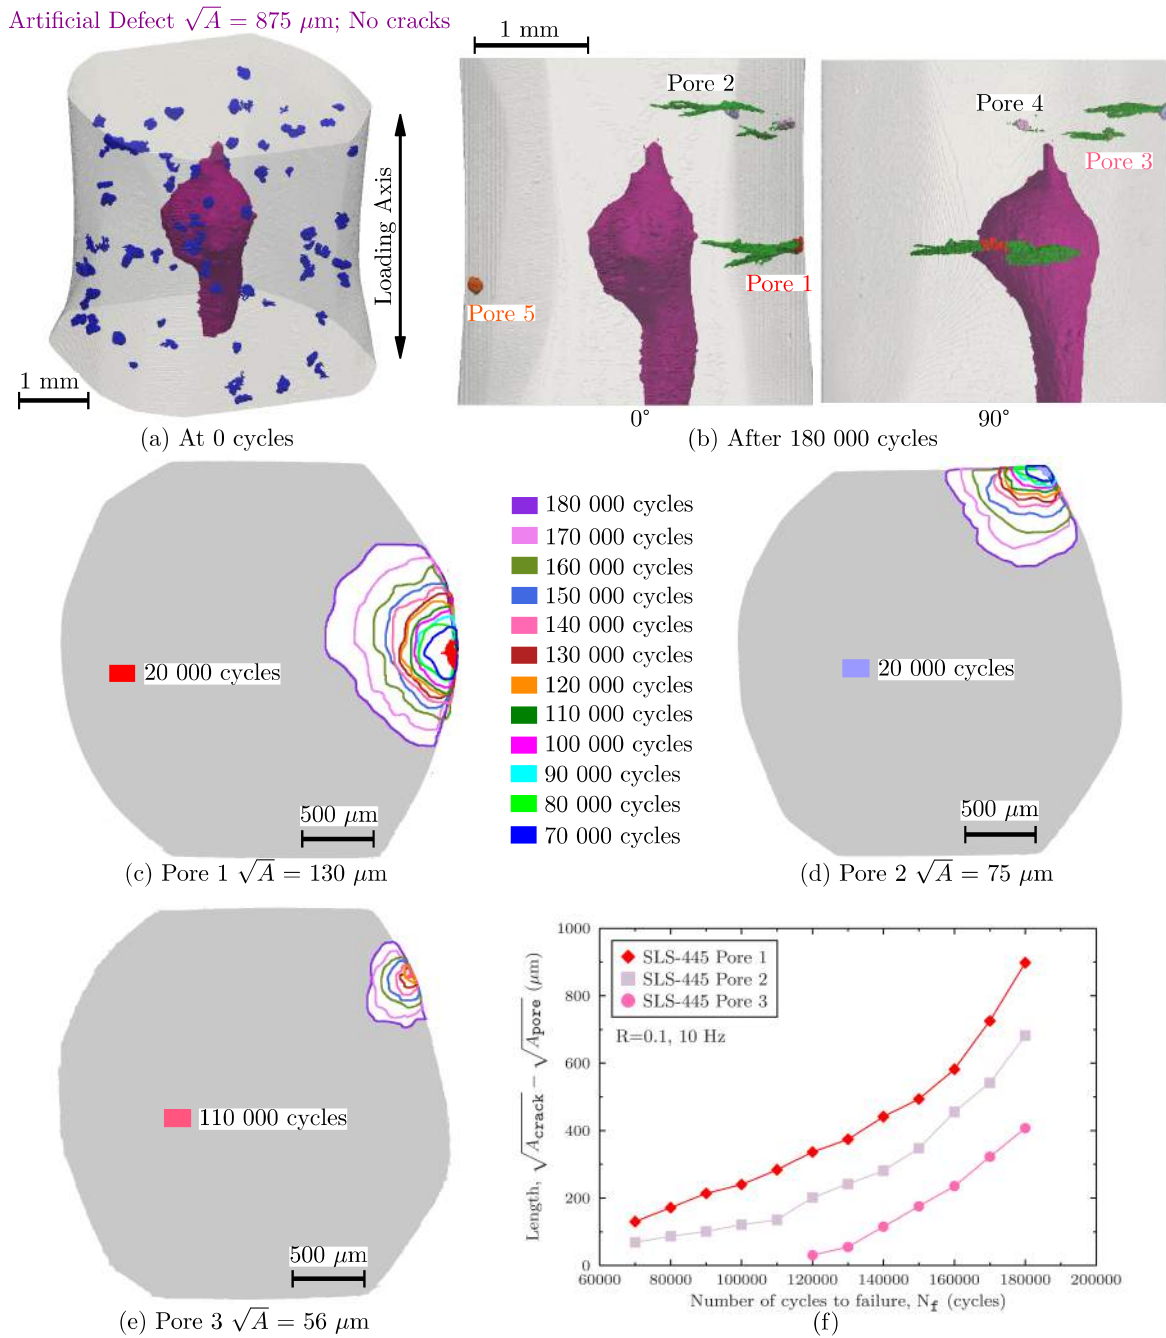
**Fig. 3.20:** (a) Defect distribution at 0 cycles within SLS-445 specimen gage. The artificial defect is presented in dark magenta and the microporosities in blue. The fatigue testing parameters are  $N_f = 190\,000$  cycles and  $\sigma_{\max} = 140$  MPa. (b) 3D rendering after 180 000 cycles at  $0^\circ$  and  $90^\circ$  only showing the five pores which nucleated a surface crack. (c) Y projection of the main growth stages for the crack nucleated at Pore 1. (d) For the case of Pore 2 and (e) for Pore 3. (f) Plot of the crack propagation ( $\sqrt{A_{crack}} - \sqrt{A_{pore}}$ ) against the number of cycles ( $N_f$ ) for these three pores.

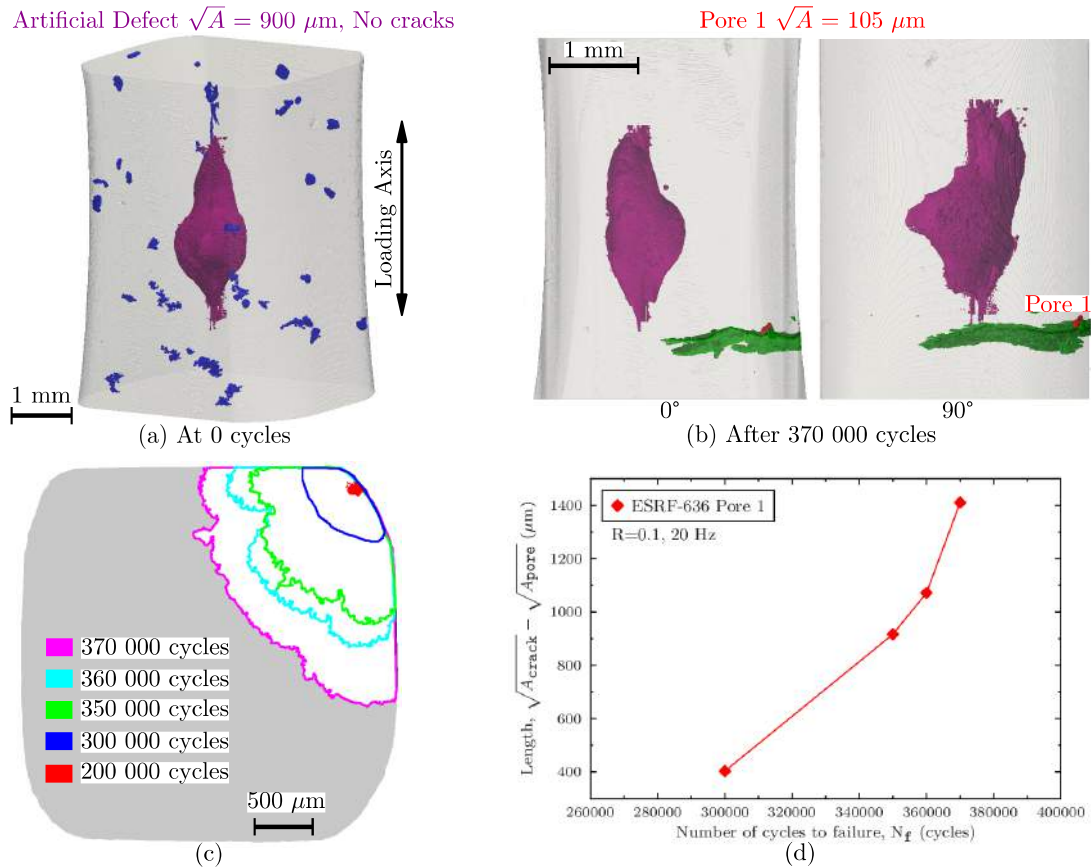
**Fig. 3.21:** (a) 3D rendering at 0 cycles of the defect population within the gage of ESRF-636 specimen. (b) 3D renderings at 0° and 90° after 370 000 cycles showing the surface crack (in green) formed at Pore 1. The fatigue testing parameters are  $N_f = 370\,000$  cycles and  $\sigma_{\max} = 105 \text{ MPa}$ . (c) Y projection of the main growth stages for this crack. (d) Plot of the crack propagation ( $\sqrt{A_{\text{crack}}} - \sqrt{A_{\text{pore}}}$ ) against the number of cycles ( $N_f$ ) for Pore 1.

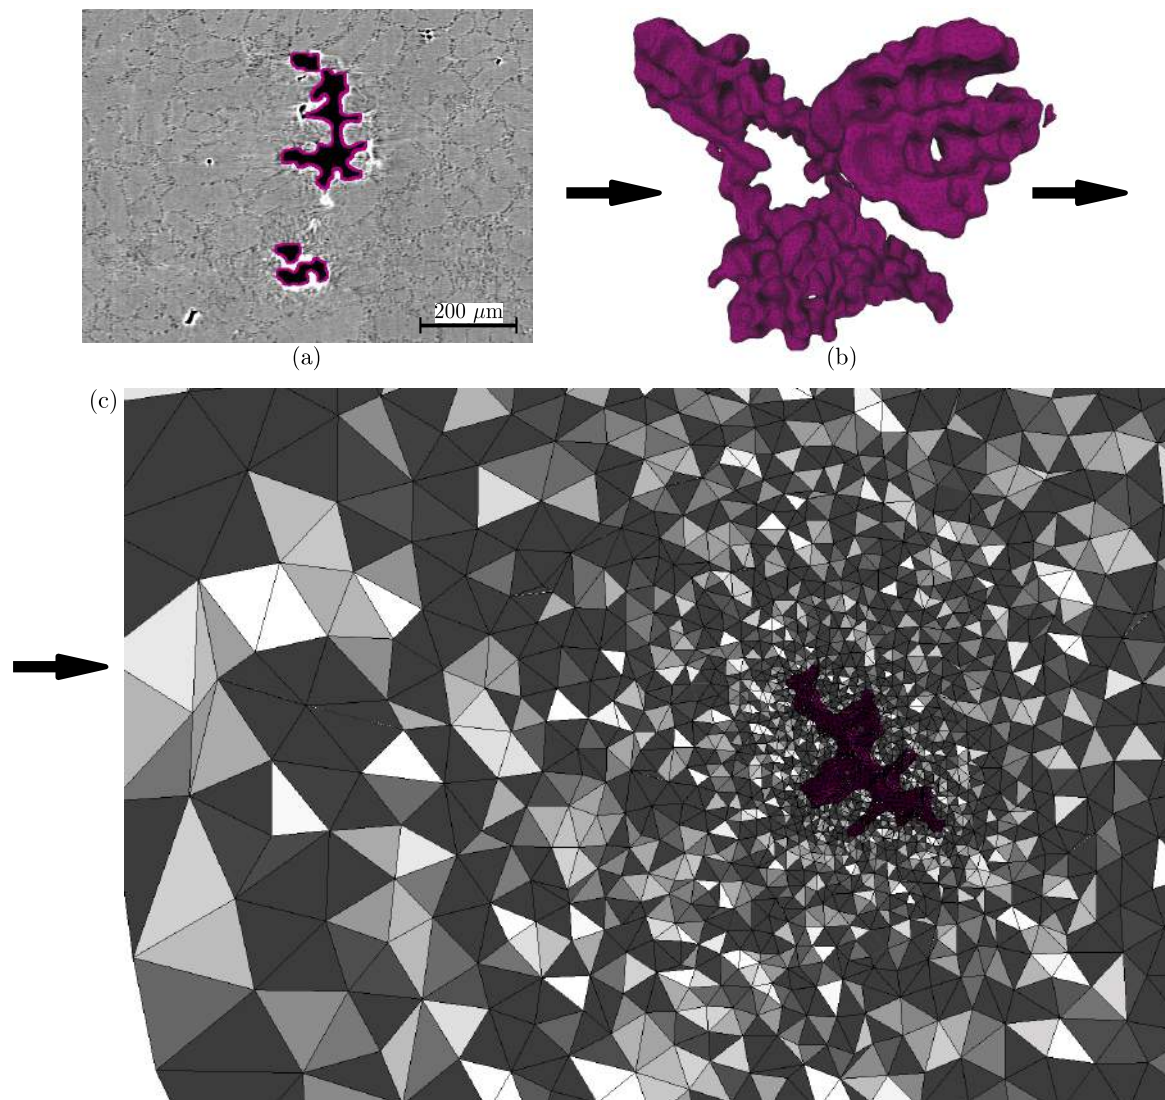
**Fig. 3.25:** (a) Synchrotron tomographic 2D image of a microshrinkage pore (voxel size =  $1.7 \mu\text{m}$ ). (b) 3D rendering of the surface mesh (34 214 triangles) of this pore generated using Avizo + Gmsh. (c) Gmsh rendering of a volume mesh showing fine tetrahedra around the pore surface and rough tetrahedra near the free surface.

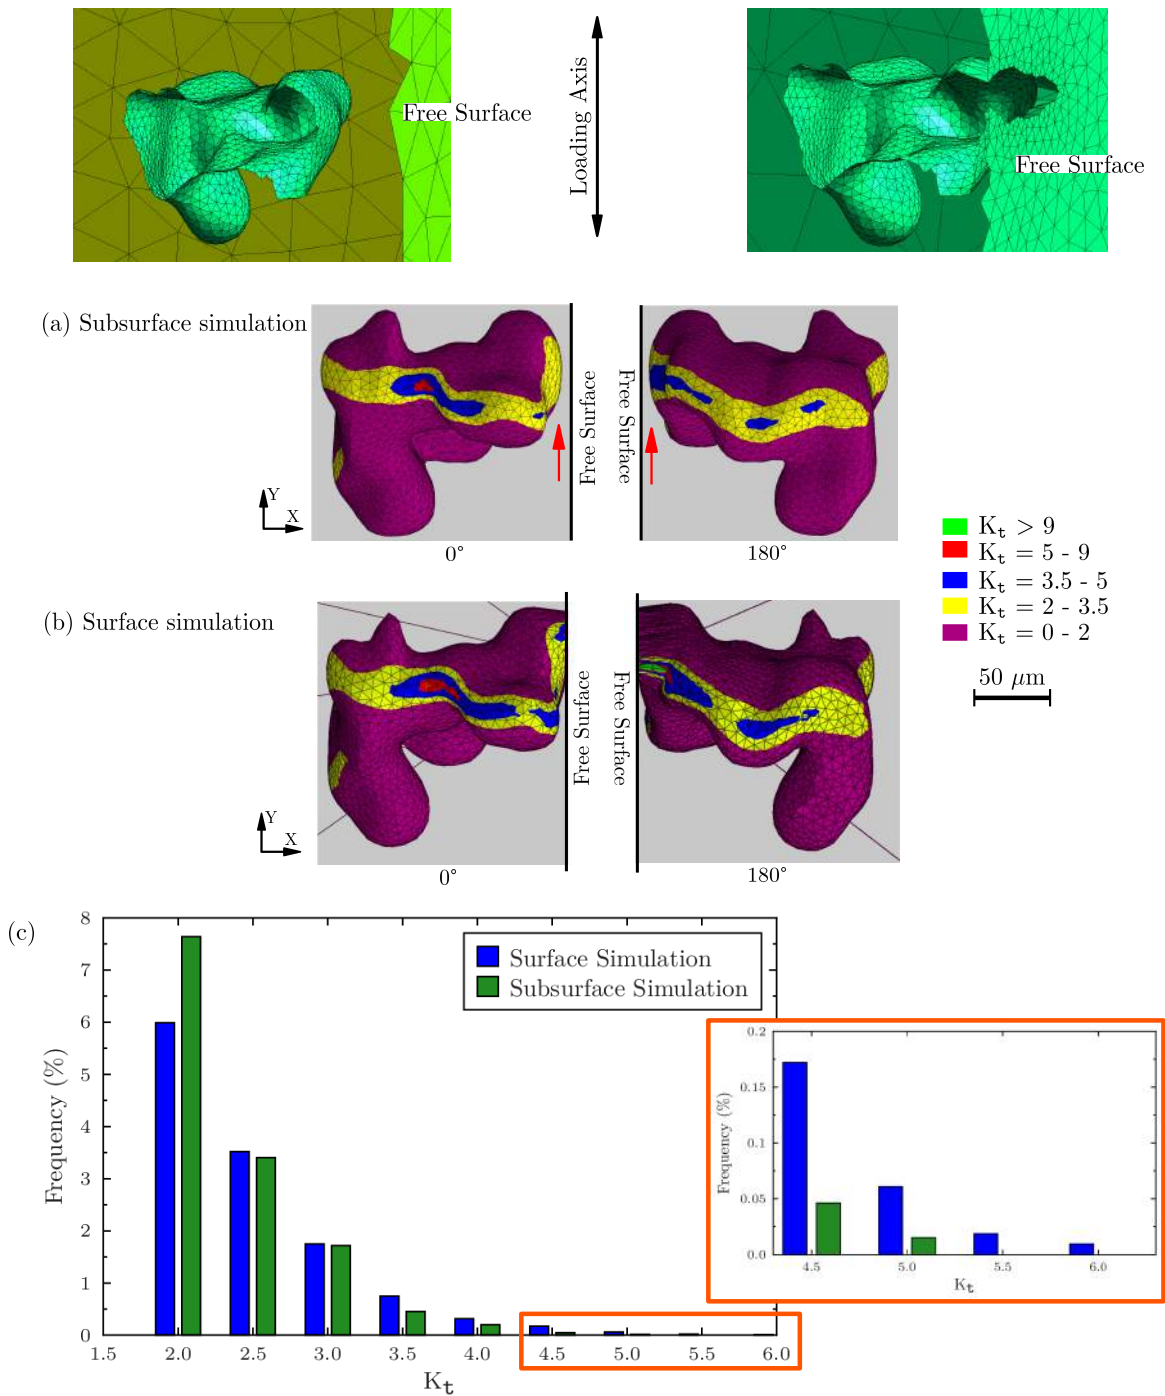
**Fig. 3.26:** (a)  $K_t$  evaluation obtained in a FE subsurface simulation. (b)  $K_t$  evaluation on the same pore but obtained in a FE surface simulation. (c) Histogram showing the frequency of counts against the different  $K_t$  values of FE surface and subsurface simulations performed for the same pore.

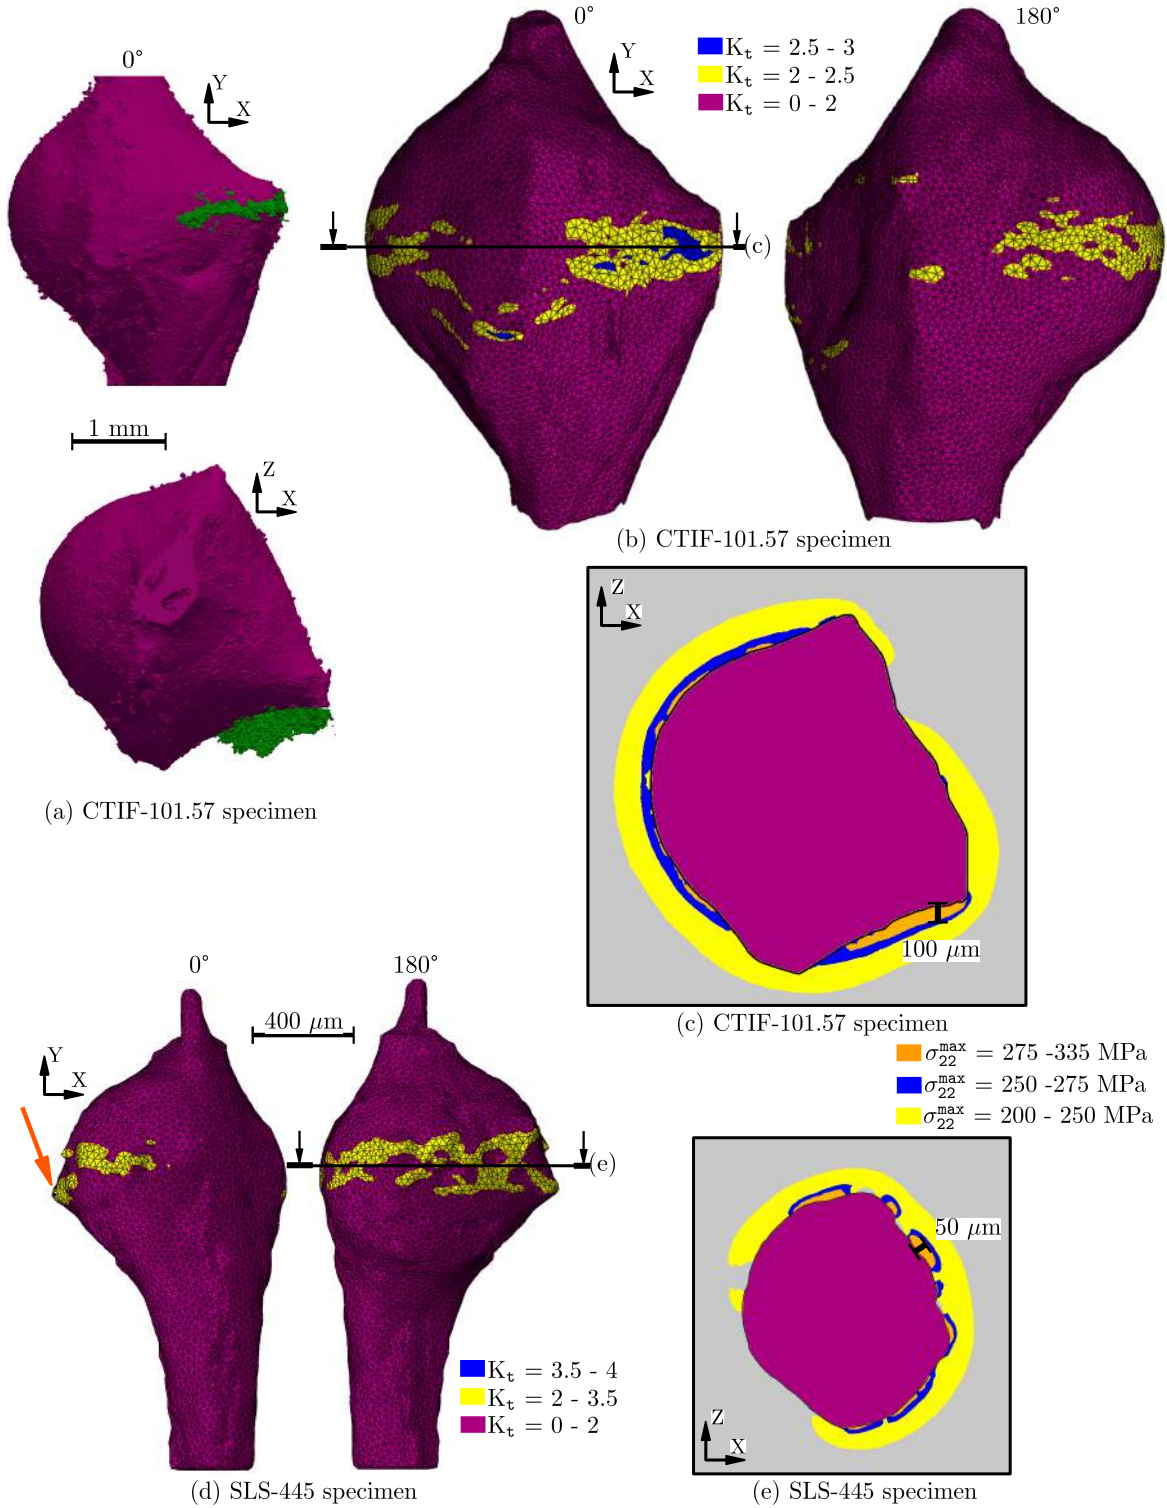
**Fig. 3.27:** (a) 3D renderings of the artificial defect of CTIF-101-57 specimen showing the internal crack (in green) formed at its equator after 938 500 cycles ( $\sqrt{A} = 2064 \mu\text{m}$ ,  $\sigma_{\text{max}} = 140 \text{ MPa}$ ). (b)  $K_t$  evaluation over the artificial defect profile of CTIF-101-57 specimen. (c) Slice performed along the "equator" of the artificial defect (CTIF-101-57 specimen) on a plane perpendicular to the loading direction showing elasto-plastic results. (d)  $K_t$  evaluation over the artificial defect profile of SLS-445 specimen ( $\sqrt{A} = 875 \mu\text{m}$ ,  $\sigma_{\text{max}} = 140 \text{ MPa}$ ). Orange arrow indicates the location of a small blue ( $K_t = 3.5 - 4$ ) region. (e) Slice performed along the "equator" of the artificial defect (SLS-445 specimen) on a plane perpendicular to the loading direction showing elasto-plastic results.

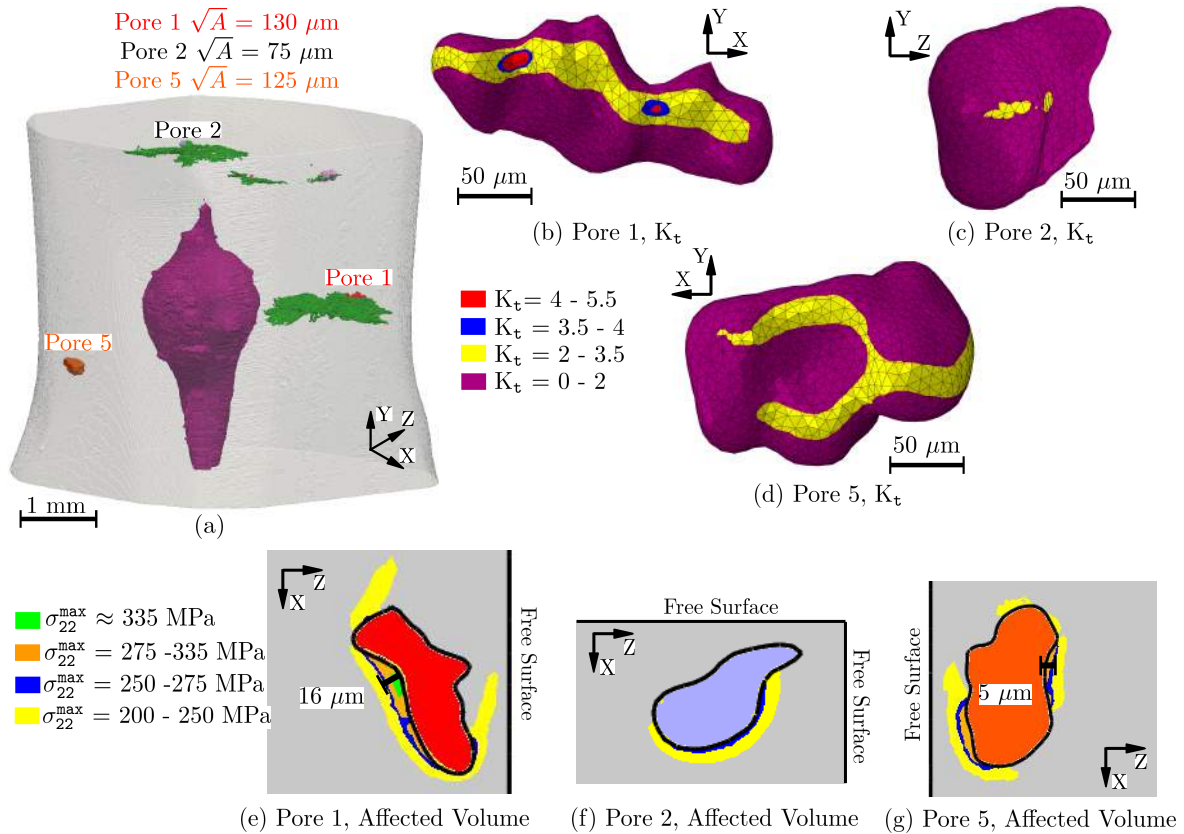
**Fig. 3.28:** (a) 3D rendering of SLS-445 specimen showing the artificial defect (in darkmagenta,  $\sqrt{A} = 875 \mu\text{m}$ ) and the pores which nucleated surface cracks. The fatigue testing parameters are  $N_f = 190\,000$  cycles,  $\sigma_{\text{max}} = 140 \text{ MPa}$ . (b)  $K_t$  evaluation for Pore 1 (crack nucleation after 20 000 cycles). (c)  $K_t$  evaluation for Pore 2 (crack nucleation after 20 000 cycles). (d)  $K_t$  evaluation for Pore 5 (crack nucleation after 170 000 cycles). (e) Slice performed along the middle plane perpendicular to the loading direction for Pore 1 and showing elasto-plastic results. (f) Same as before but for Pore 2 and (g) Pore 5. It must be noted that the values obtained within the ligament, between the free surface and the pore, are not taken into account.

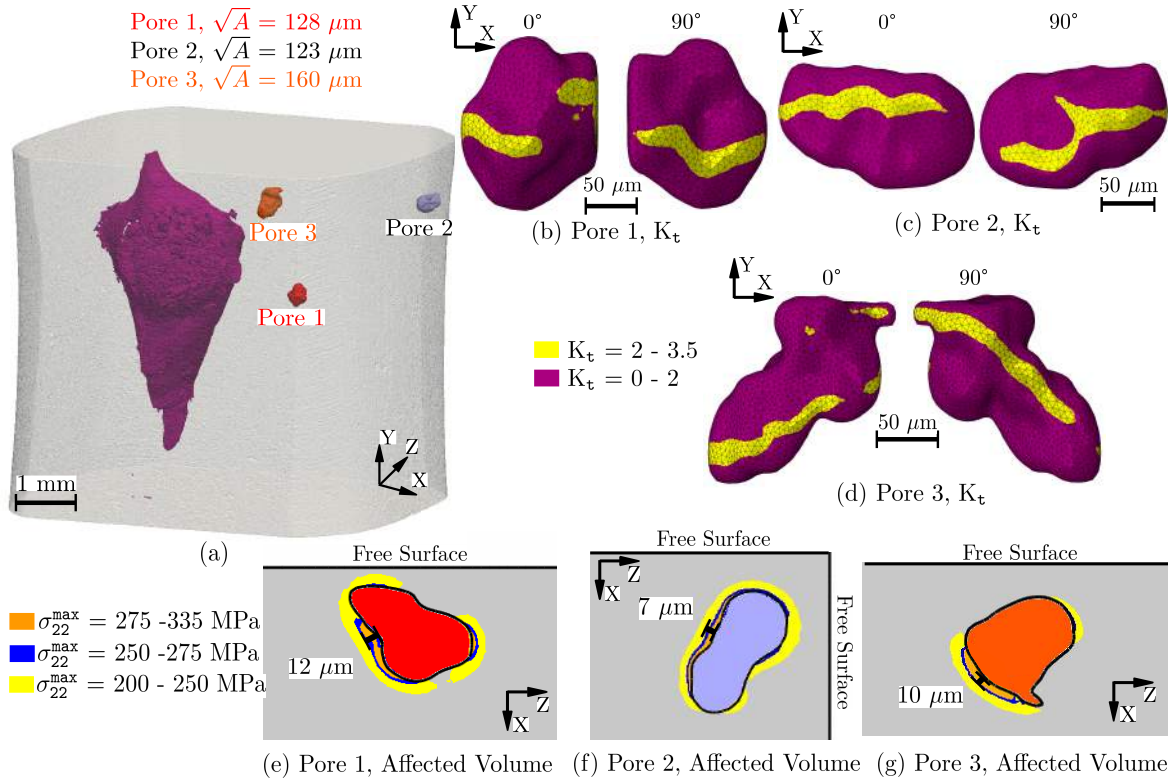
**Fig. 3.29:** (a) 3D rendering of SLS-449 specimen showing the artificial defect and three surface pores which did not nucleate any crack. The fatigue testing parameters are  $N_f = 140\,000$  cycles,  $\sigma_{\text{max}} = 140 \text{ MPa}$ , Artificial Defect  $\sqrt{A} = 830 \mu\text{m}$ . (b)  $K_t$  evaluation for Pore 1 (no crack nucleation after 140 000 cycles). (c)  $K_t$  evaluation for Pore 2 (no crack nucleation after 140 000 cycles). (d)  $K_t$  evaluation for Pore 3 (no crack nucleation after 140 000 cycles). (e) Slice performed along the middle plane perpendicular to the loading direction for Pore 1 and showing elasto-plastic results. (f) Same as before but for Pore 2 and (g) Pore 3.

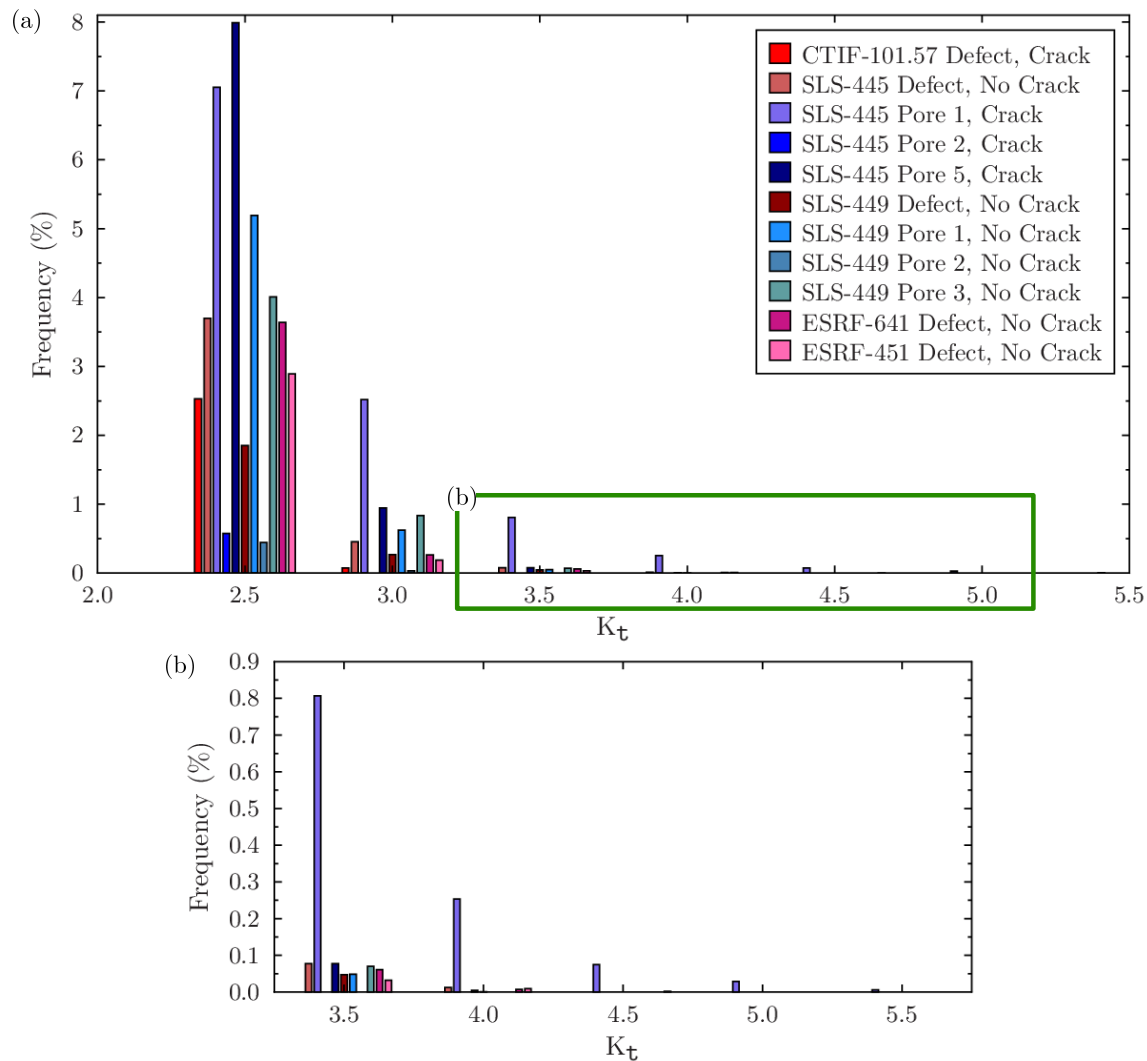
**Fig. 3.30:** (a) Histogram showing the frequency of counts against the different  $K_t$  values of FE simulations performed on CTIF-101.57, SLS-445, SLS-449, ESRF-641 and ESRF-451 specimens. (b) Detail on the  $K_t$  values ranging from 3.5 to 5.5.

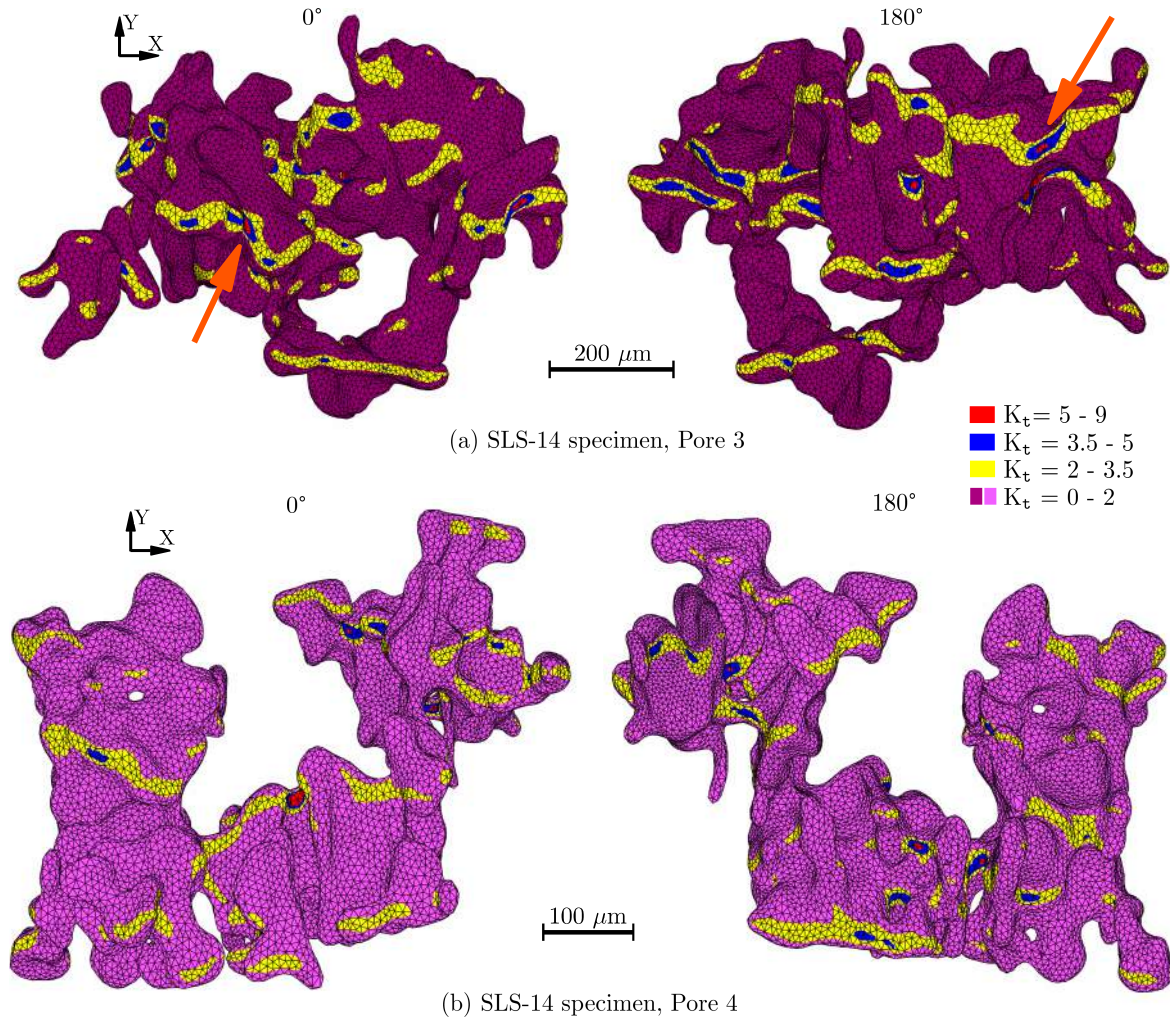
**Fig. 3.31:** (a) 3D renderings at 0° and 180° of the  $K_t$  evaluation on Pore 3 (SLS-14 specimen). (b) The same as before but for Pore 4 (SLS-14 specimen). Orange arrows indicate some of the largest red-blue zones ( $K_t = 9-5$ ) that are formed over the pore convoluted morphology.

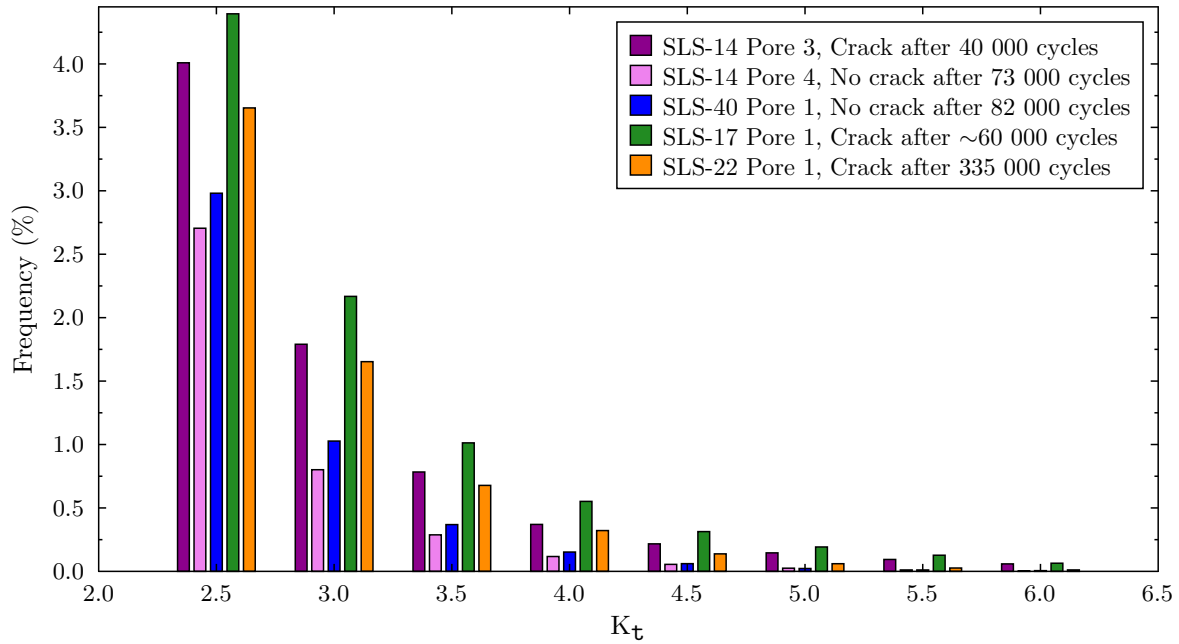
**Fig. 3.32:** Histogram showing the frequency of counts against the different  $K_t$  values obtained over the surface of natural internal defects.

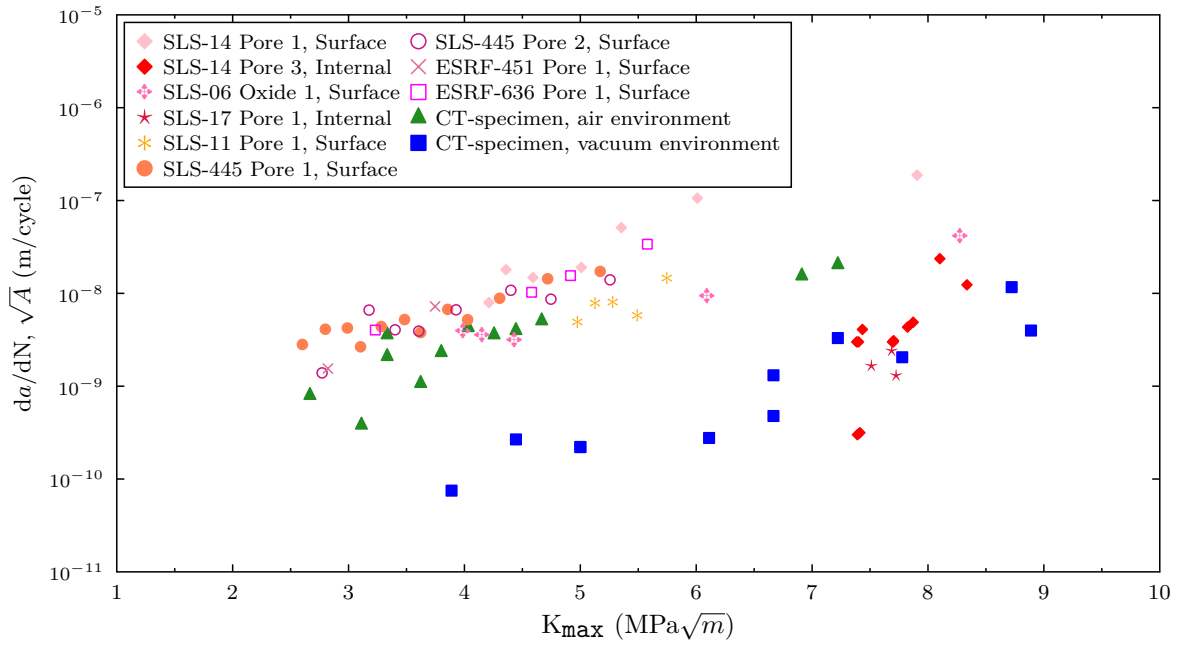
**Fig. 3.35:** Plot of  $da/dN$  against the stress intensity for synchrotron small cracks along with the long crack results obtained with CT specimens at ENSMA.

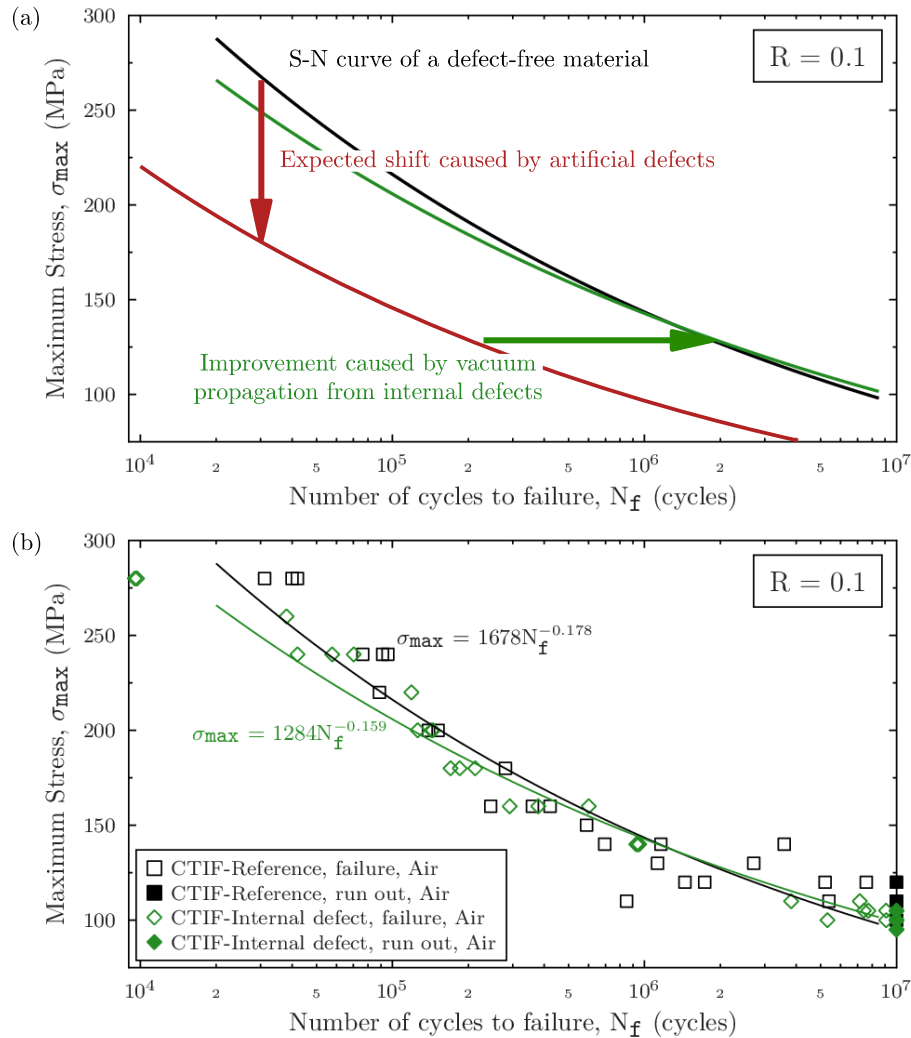
**Fig. 3.36:** (a) S-N curve showing the expected shifts produced by the cycling of  $\varnothing_{eq} \approx 2$  mm internal artificial defect in different environments (air and vacuum). (b) S-N curves for the reference material (which is considered to be defect-free at the surface) and specimens containing internal artificial defects of  $\varnothing_{eq} \approx 2$  mm cycled in ambient air.
